# Human Impact Loads On Roofs

**A Maitra** BSc CEng MICE  
HM Principal Specialist Inspector,  
Health and Safety Executive,  
Room 338, Magdalen House,  
Stanley Precinct,  
Bootle, Merseyside,  
L20 3QZ  
Tel: 0151 951 4634  
Fax: 0151 922 7918  
e-mail: [hash.maitra@hse.gsi.gov.uk](mailto:hash.maitra@hse.gsi.gov.uk)

**Summary:** Currently, roofs are designed to carry loads prescribed in BS 6399. These are static loads, which are not significant in structural terms and do not represent the load of a person falling on to or stumbling on the roof. Consequently, many people fall through roofs, often to their deaths. As a result of this unacceptable situation, the Health and Safety Executive embarked on a programme to quantify human impact loads and found that they exceeded the prescribed design loads. Finally, the test results were used to develop a test for fragility of roof assemblies, which has been published as ACR[M]001:2000, to help manufacturers develop roofing products, which are safe.

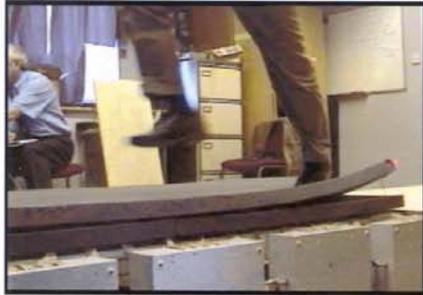
Figure 7: Video frame and pressure image of stumble event

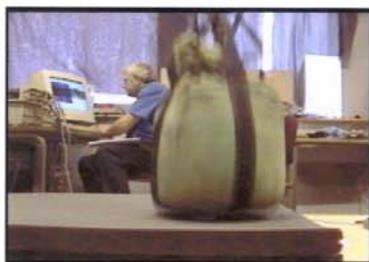
Figure 9: Video frame and pressure image of bagdrop

17. This gave the overall minimum factor to be applied to the measured “extreme” force, which was **1.9**, being the product of the factors<sup>2</sup>, **k<sub>W</sub>.....k<sub>S</sub>**, listed above in **16 a)** to **16 e)**. This was rationalised to **2.0**, and eventually defined the test for assuring non-fragility as: the dropping, under gravity, of a bag of diameter 300 mm containing 45 kg of dry sand through 1.2 m onto the surface, determined by trial-and-error.
